Name Of Dam: SCOTT'S MILL DAM
Location: LYNCHBURG CITY
Inventory Number: VA. 68001

PHASE I INSPECTION / REPORT NATIONAL DAM SAFETY PROGRAM

SCOTTS MILL DAM
CITY OF LYNCHBURG, VIRGINIA
INVENTORY NO. VA 68001

**Deward M. Martin & Associates, Inc.
August 1979**

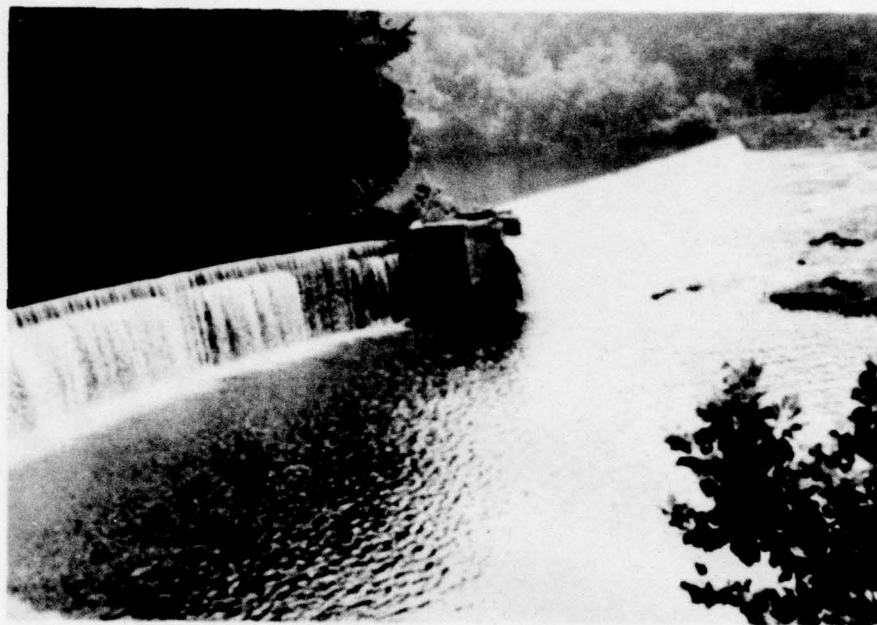
PHOTOGRAPH NO. 1
The Straight Spillway

3.1.4 Spillway: The entire dam is an ungated masonry spillway which shows no obvious signs of deterioration, however, a detailed investigation was not possible since water was flowing over the crest.

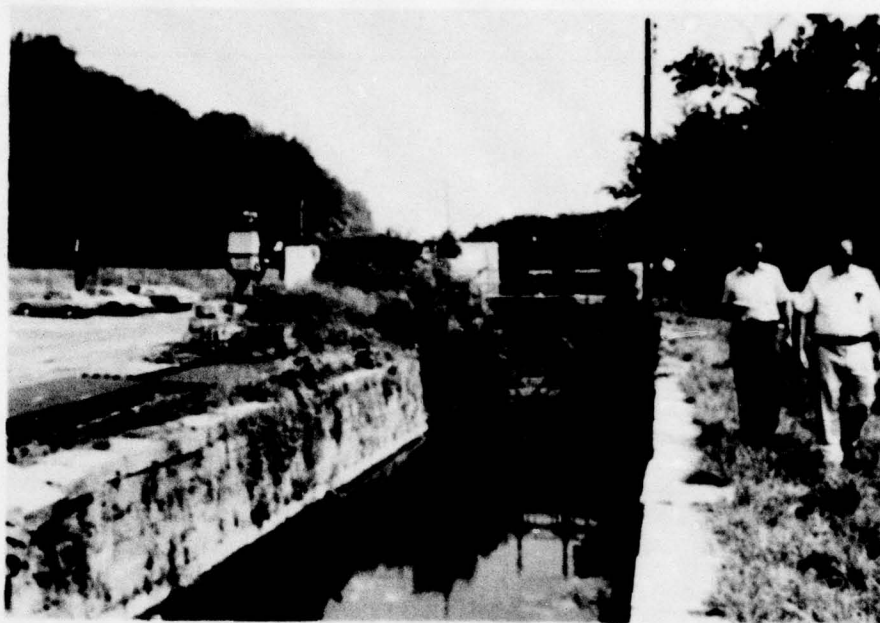
PHOTOGRAPH NO. 3
Canal and Gates

3.1.3 Appurtenant Structures: A small masonry structure is located at the tip of Daniel Island. It separates the straight and curved portions of the dam and it appears to be in good condition. The canal adjacent to the right abutment, shows no signs of significant deterioration, but there are cap stones loose and dislodged.

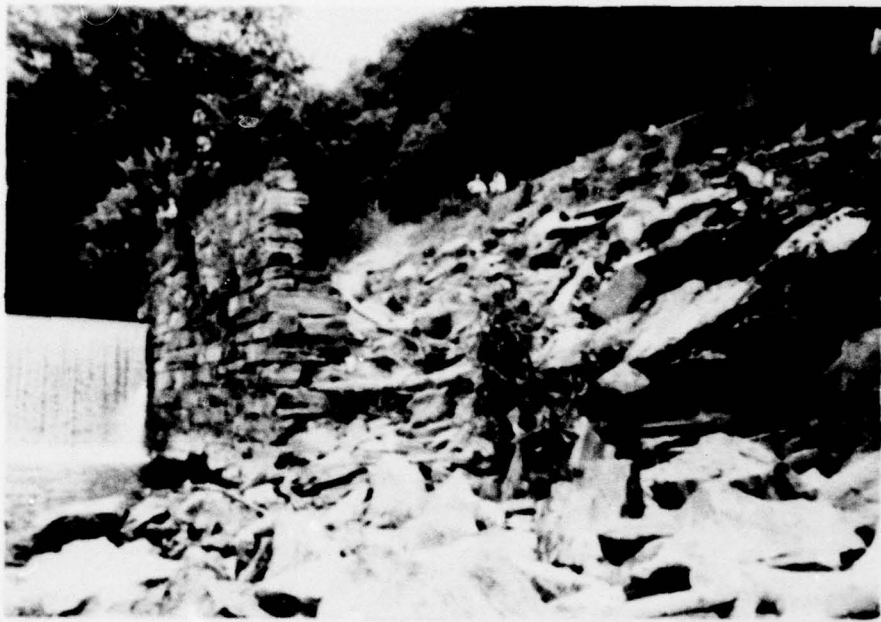
PHOTOGRAPH NO. 5
Left Abutment

3.1.2 Dam: There was no apparent vertical or horizontal misalignment of the dam and no major cracks were detected, however, since the spillway constitutes virtually the entire dam, much of the structure was under water and, therefore, inaccessible. Some seepage was noted through the berm separating the canal and the river at the right abutment. Dampness was detected at the left abutment and there was some intermittent seepage in the abutment joints.
